CIGRE 2023 Sendai Colloquium, Japan, 3-7 October 2023

Paper ID 5315498,
C4 - Power System Technical Performance,
(PS2) – Reliability of OHL, Advanced Construction and Maintenance

Investigation on Inverter Duty Transformer Failures at Grid Connected Solar Photovoltaic Plants: Challenges and Recommendations

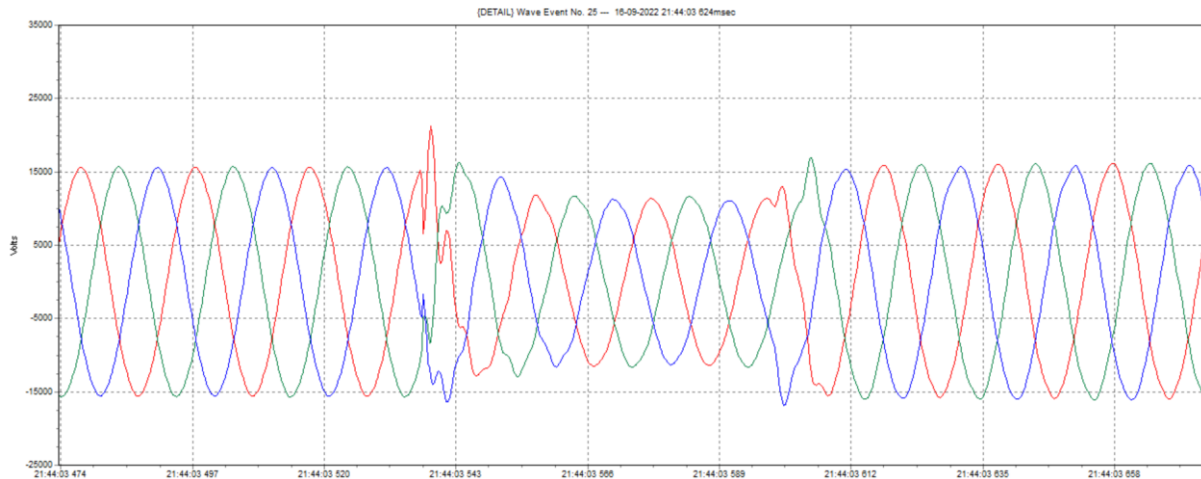
- Also, the 28 MVA IDT Transformer is Delta Connected on the 11 kV Side and Star Connected on the 380V Side.
- The significant number of Transients recorded daily is a matter of concern for further investigation. VCB and IDT failures reported at SPV Plant Sites are mainly because of Switching Transients, which may occur due to external or internal sources.
- In addition, PQ Monitoring was only done at one of the IDTs at the SPV Plant, while the site has seven 2.8 MVA IDTs and one 1.4 MVA IDT.

Figure 2 Simultaneous Switching Transient and Voltage Sag at SPV Site 1

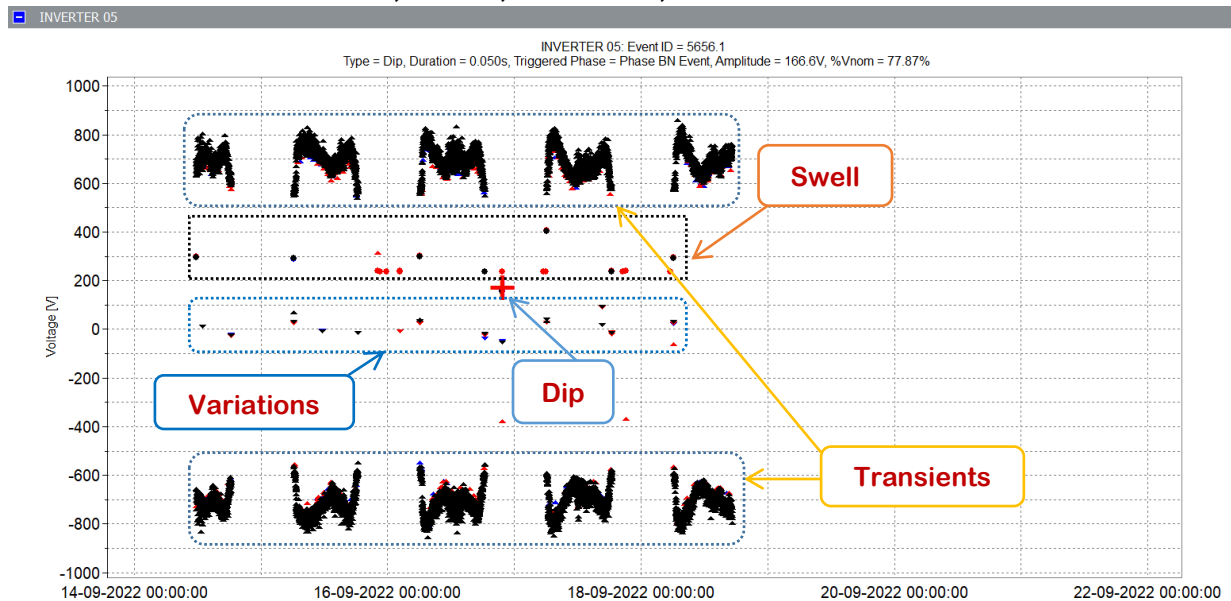
- As per the PQ monitoring, the following observations were highlighted for further analysis:
- A total of **10001** PQ events were recorded, and the majority of them were "**Transients**" followed by "**Fast Voltage Variations**" and "**Voltage Swell**" with only one "**Voltage Dip**" during the one-week recording.
- The majority of the PQ events were "**Voltage Transients**" and occurred in **Phase A (9450)**
- A moderate number of "**Waveform Variations**" (66) and "**Voltage Swell**" (29) occurred during the monitoring period, while the "**Waveform Variations**" occurred in all three phases equally but whereas '**Voltage Swell**' occurred mainly in **Phase B (17)**
- The remaining PQ Events were **Rapid Voltage Changes (RVC)** and occurred in ALL three phases.
- Table 2 shows ONE **Voltage Dip** and 17 **Voltage Swell** recorded during the one-week monitoring period.

Figure 3 Power quality events recorded at SPV Site 1 on LT Side

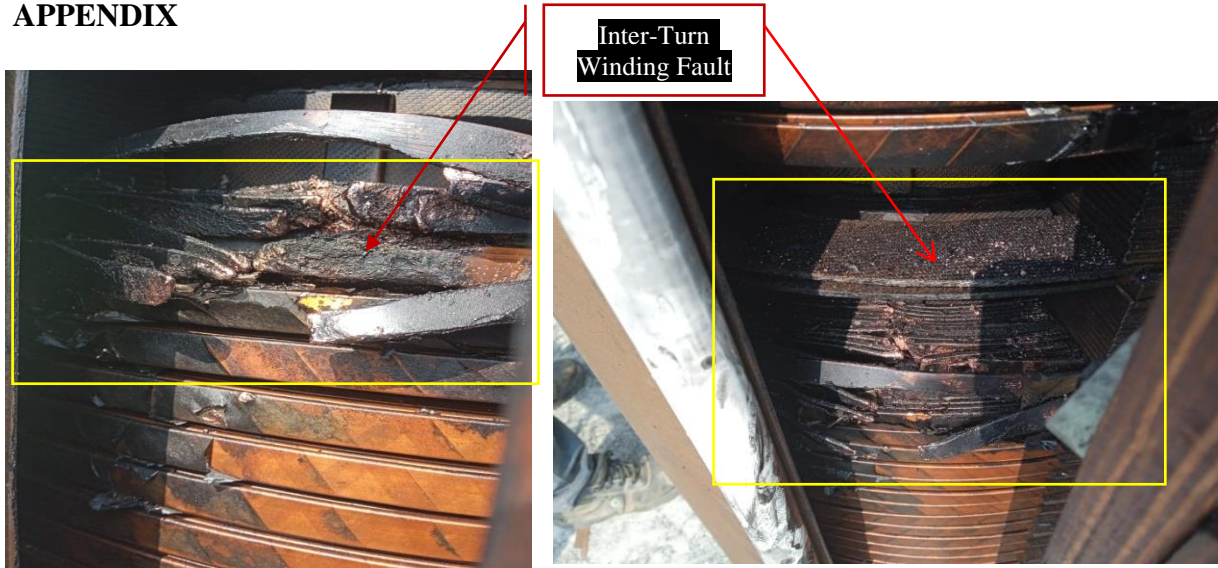
Figure 4(a) Inter-turn Fault of 1-Phase of 12.5 MVA Inverter Duty Transformer (b) Damaged Winding

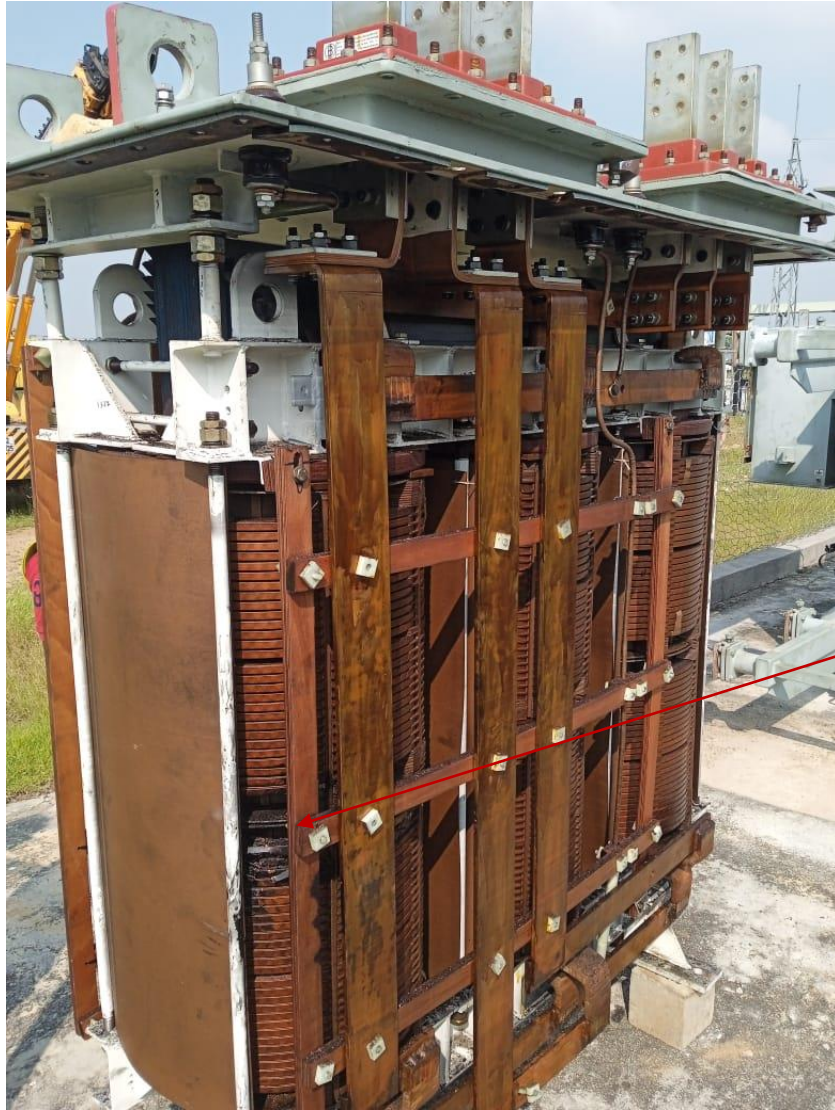
Only one phase
and several
turns failure of
12.5 MVA

Figure 4(c) 12.5 MVA Inverter Duty Transformer Failure
