भारतीय मानक Indian Standard IS 16686 : 2018 IEC TR 62662 : 2010

Guidance for Production, Testing and Diagnostics of Polymer Insulators with Respect to Brittle Fracture of Core Materials

GUIDANCE FOR PRODUCTION, TESTING AND DIAGNOSTICS OF POLYMER INSULATORS WITH RESPECT TO BRITTLE FRACTURE OF CORE MATERIALS

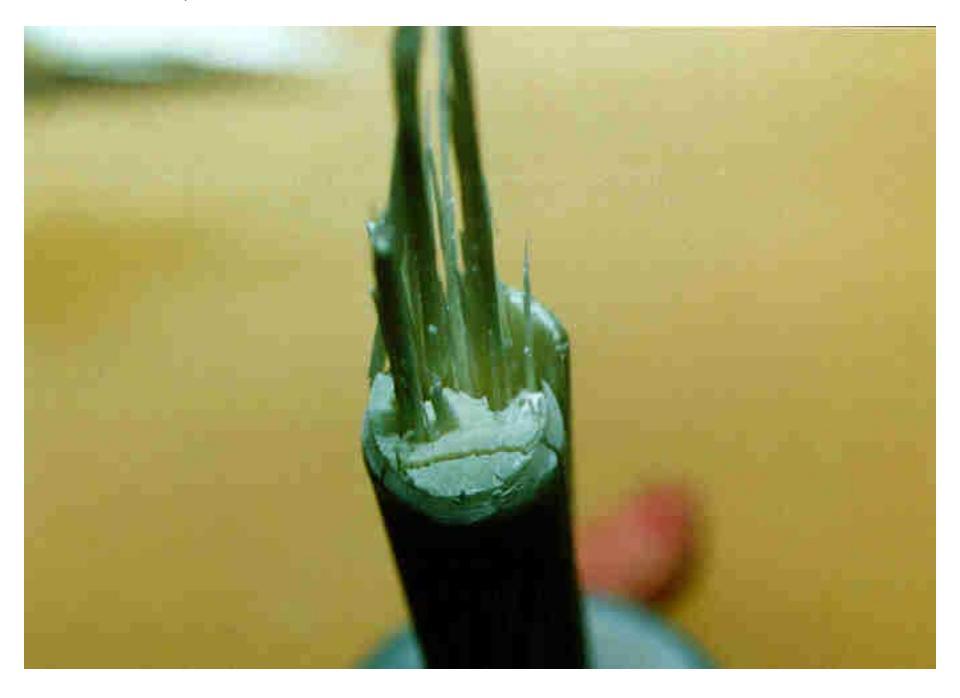
Figure 1 – Typical brittle fracture

The macroscopic features associated with the brittle fracture of an FRP core rod have been described by CIGRE [2] ¹. A typical brittle fracture is shown in Figure 1. The fracture surfaces typically have the following characteristics:

- a smooth, clean, planar surface perpendicular to the core axis, comprising a portion of the rod cross-section. Multiple failure planes separated by axial delamination may be present;
- normal tensile fracture (fibrous) in the remaining rod cross-section.
